Preliminary Engineering Report

Chistochina Water and Sewer Service to 15 Homes & Washeteria Improvements

Project Number 25-CZO-TO-007

65% Draft

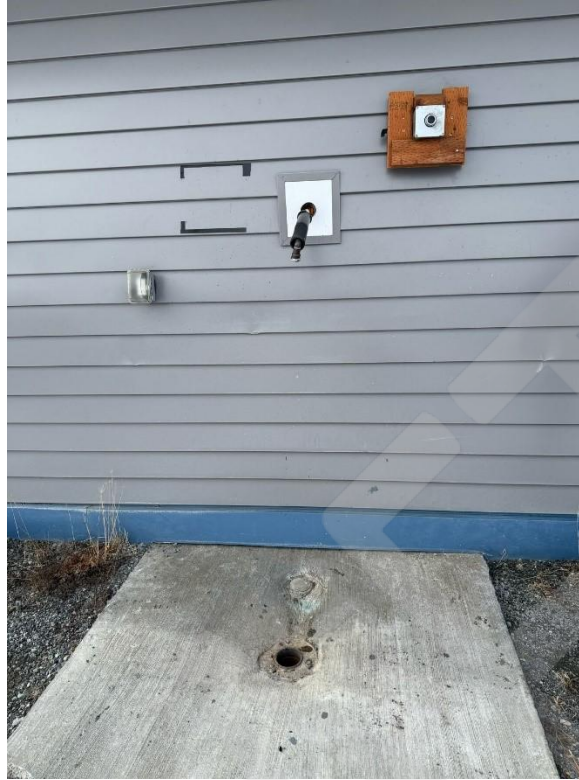
Figure 7. Water hauling point at the Utility Building

The water fill point pipe should be angled downwards from inside the facility to the fill point to allow it to fully drain when the valve is closed to prevent freezing when the valve is closed. The valve is functional, but the controls for the valve are not, and the handle for the valve is broken. The valve and its controls should be replaced.

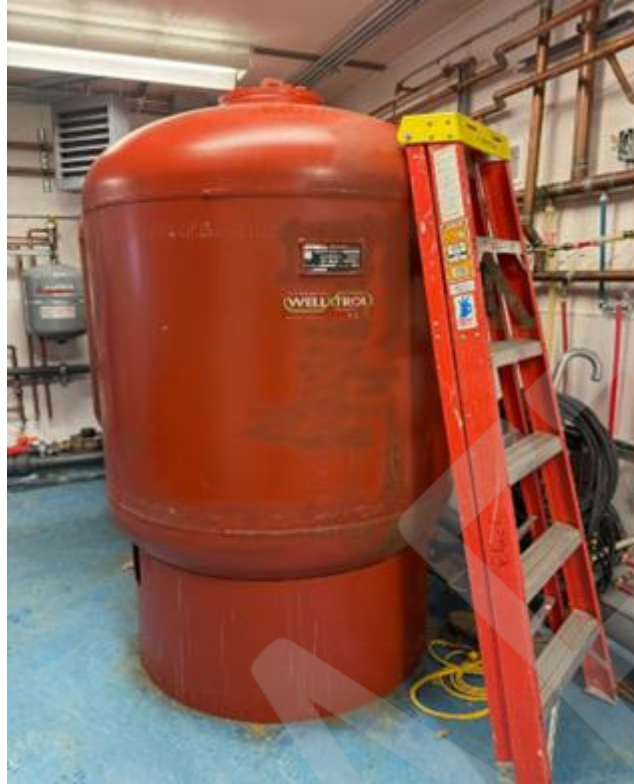
Figure 9. Pressure Tank in the Water Utility Building

A water leak may be present in the distribution system past the Water Utility Building. When the valve is open, the well will pump for a few seconds, bringing the pressure up to 60 pounds per square inch (PSI). The pump will then shut off and within a few seconds the pressure will drop back to 0 PSI. The pressure is maintained if the valve to the distribution system is shut off. The water meter indicates an approximate 0.1 to 0.2 gallons of water flows through the water meter during these few seconds of operation. Further investigation would be necessary to determine the root cause of the system's inability to retain pressure.

Along with the replacement of equipment, a leak detection effort would be performed in order to investigate the root cause of the system's inability to maintain pressure. Due to the unreliability of power to the Water Utility Building, a battery energy storage system could help prevent damage caused by power surges, voltage sag, overvoltage, and similar issues, and also serve as backup power during power outages.

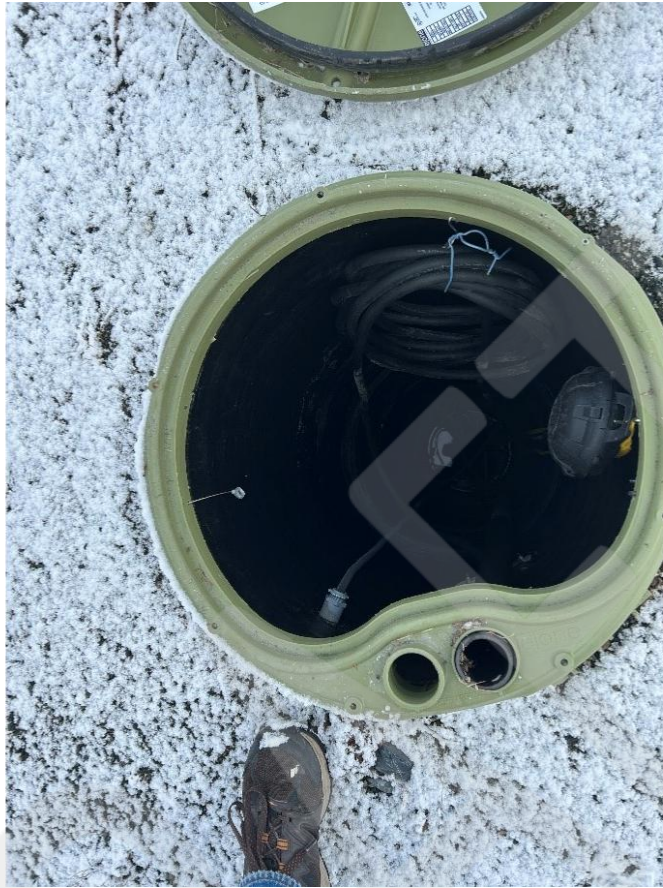
The Community Septic System consists of three lift stations, a septic tank and a leach field. A glycol heating loop is used to prevent freezing. The system serves the Water Utility Building, the Community Building and the Tribal Office. During the site visit, it was noted that the lift stations were not insulated.

If the pumps were to freeze, the damage to the pumps would be permanent. The pumps do not appear to have been replaced since their initial installation and may have suffered freezing damage at least once.

Figure 10. Lift station near Water Utility Building, with no evidence of insulation

The lift station pumps should be evaluated and replaced if necessary. The lift station themselves should be upgraded with additional insulation to mitigate the risk of freezing.

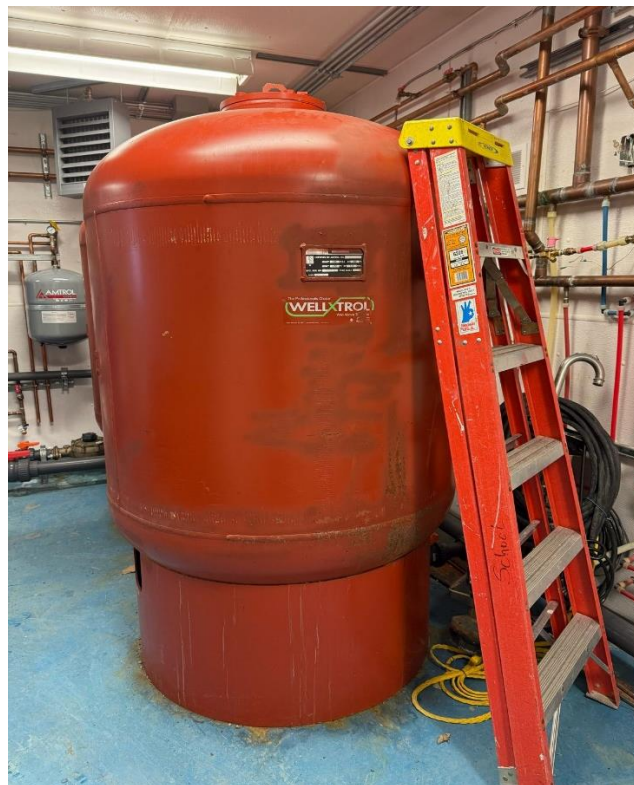
With the information gathered during the site visit with community members and water operator, the water facility building seems to have issues with bladder tanks and control panels, that are not functioning as intended. A water leak may be present in the distribution system past the water facility building. When the valve is open, the well will pump for a few seconds, bringing the pressure up to 60 pounds per square inch (PSI). The pump will then shut off and within a few seconds the pressure will drop back to 0 PSI. The pressure is maintained if the valve to the distribution system is shut off. The water meter indicates an approximate 0.1 to 0.2 gallons of water flows through the water meter during these few seconds of operation. Further investigation would be necessary to determine the root cause of the system's inability to retain pressure.

Figure 4. Pressure Tank in the Water facility Building

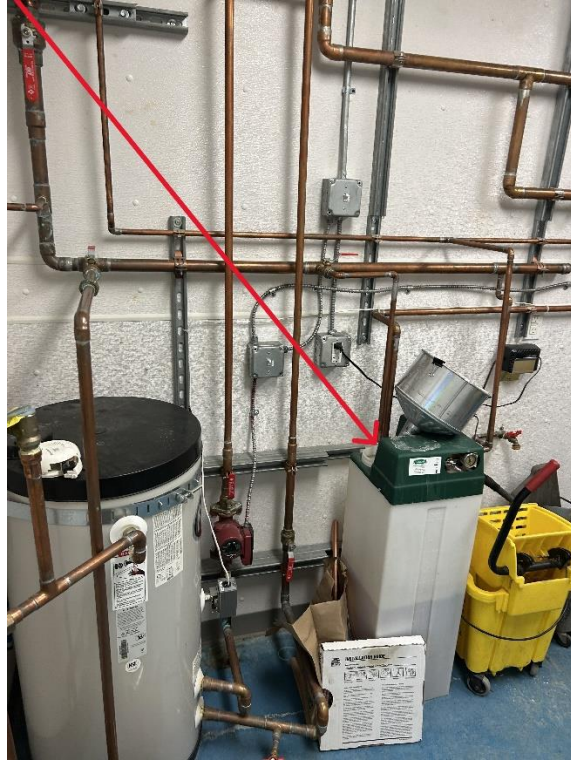
Figure 5. Cold water line to water heater. Red arrow indicates drain from cold water line into a glycol container, presenting a potential, but not immediately threatening cross-connection

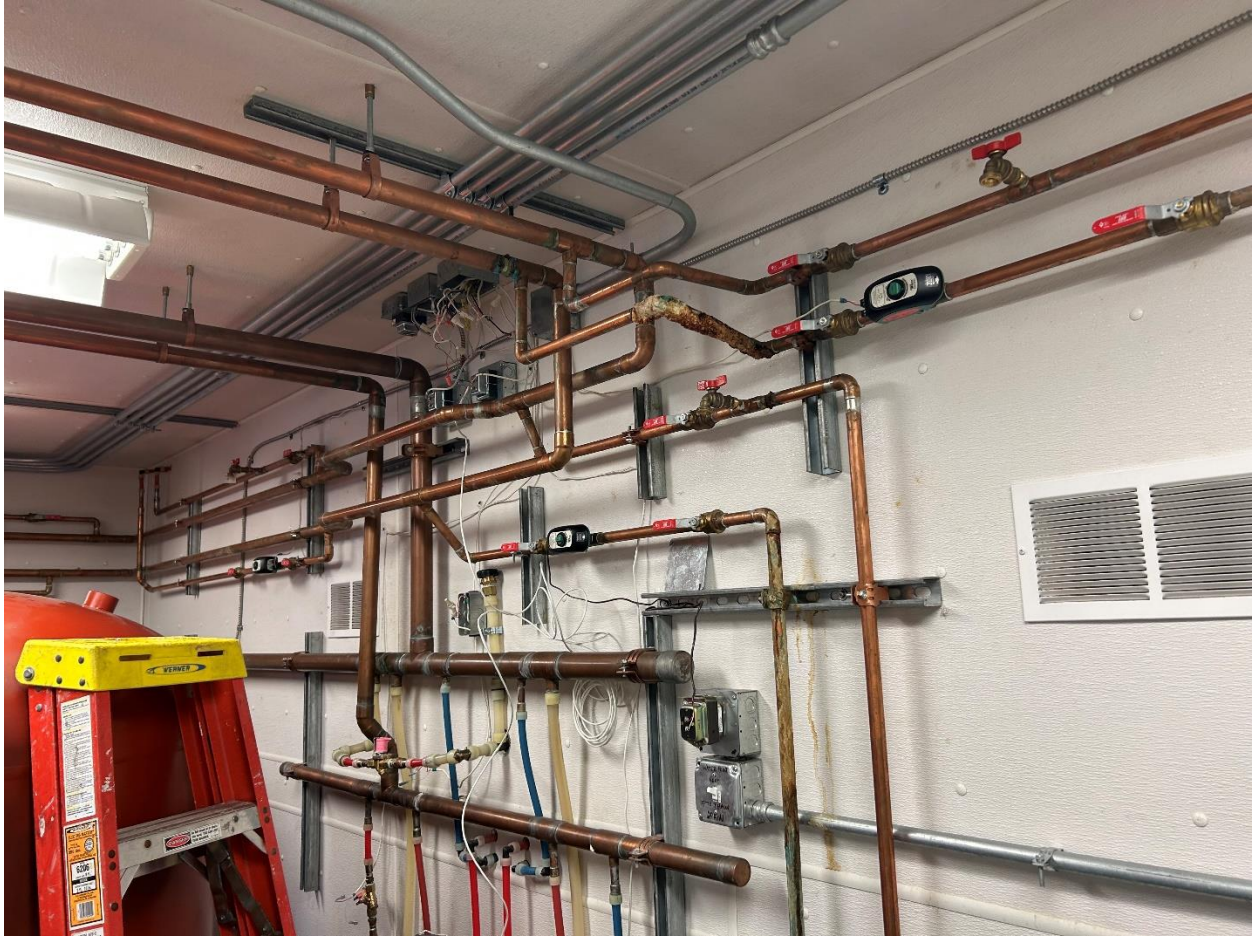
Figure 6. Pink valve in bottom left corner of this figure is the non-operational valve for the water fill point

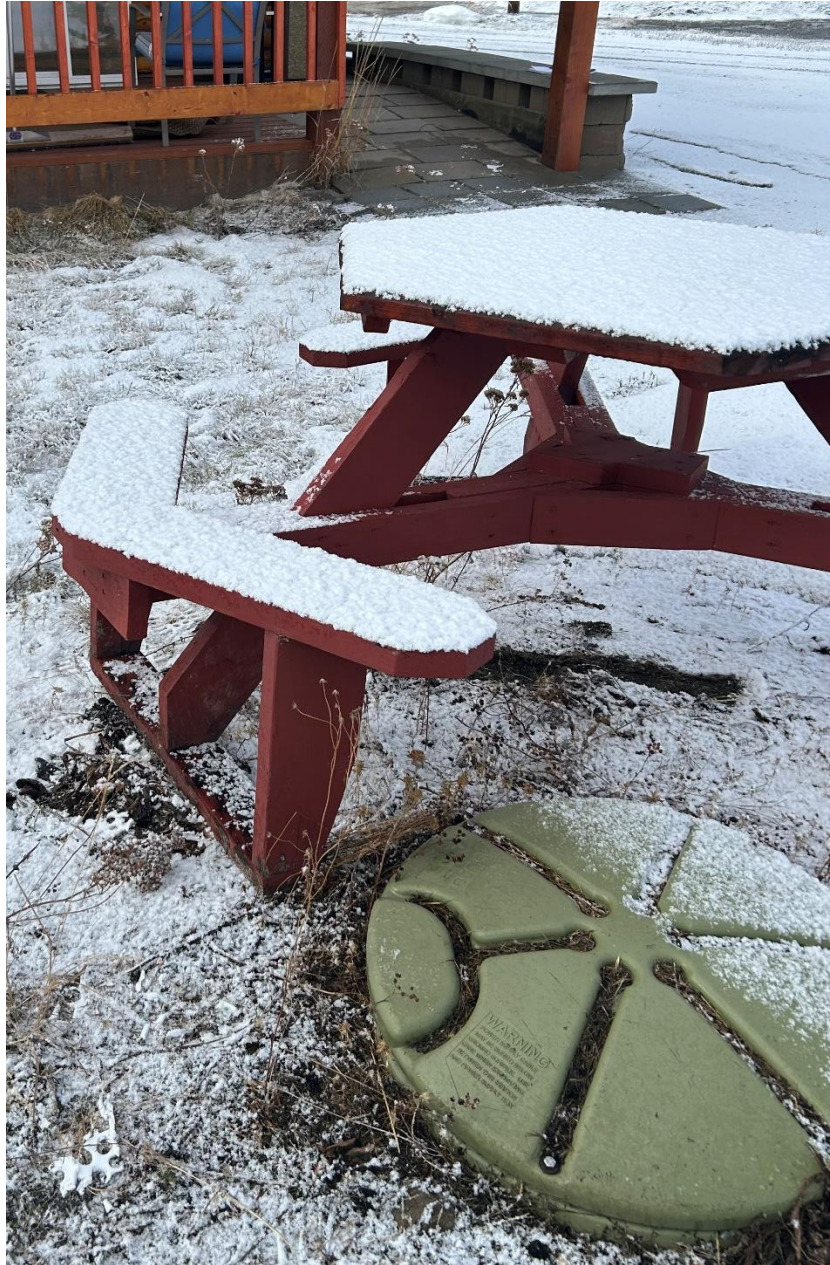
The sewer system includes three lift stations. The lift stations did not appear to be insulated. There is a glycol heating loop from the water facility building that's intended to keep it thawed out. Due to the depth of liquid in the lift stations, if the liquid freezes, the pumps in the lift stations would likely freeze and be damaged beyond repair as well. The pumps are not likely to have been replaced since they were first installed in 2016, and the typical useful life for a lift station pump varies based on how much maintenance they receive. As these pumps generally will not receive regular maintenance, they should be expected to last approximately five to ten years, and are

Figure 7. Lift Station near tribal office, typically underneath seating

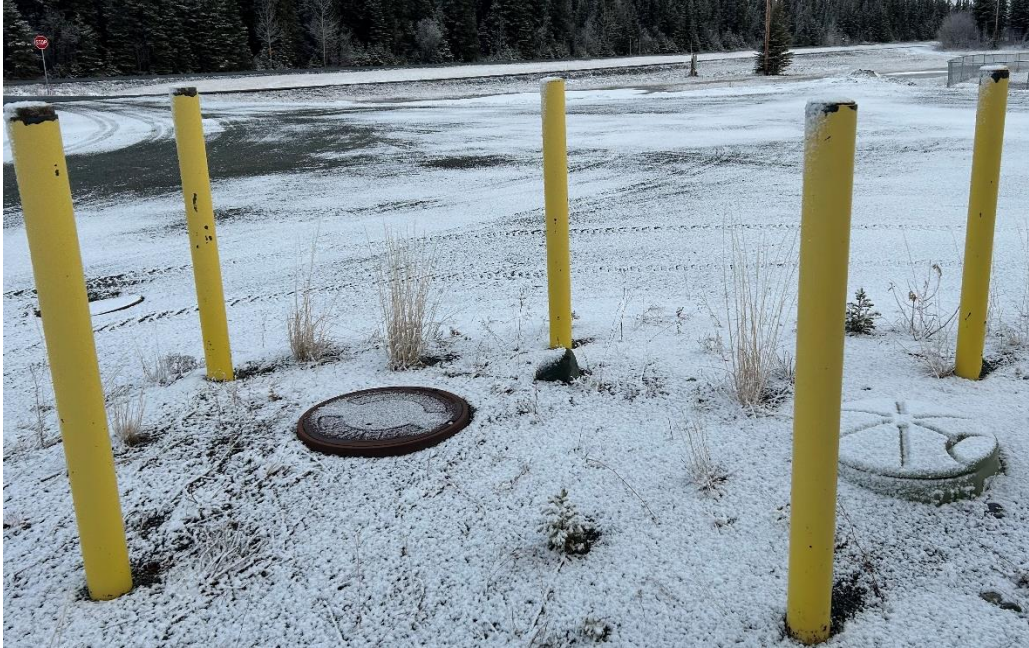
Figure 8. Lift station halfway between tribal office and water facility building

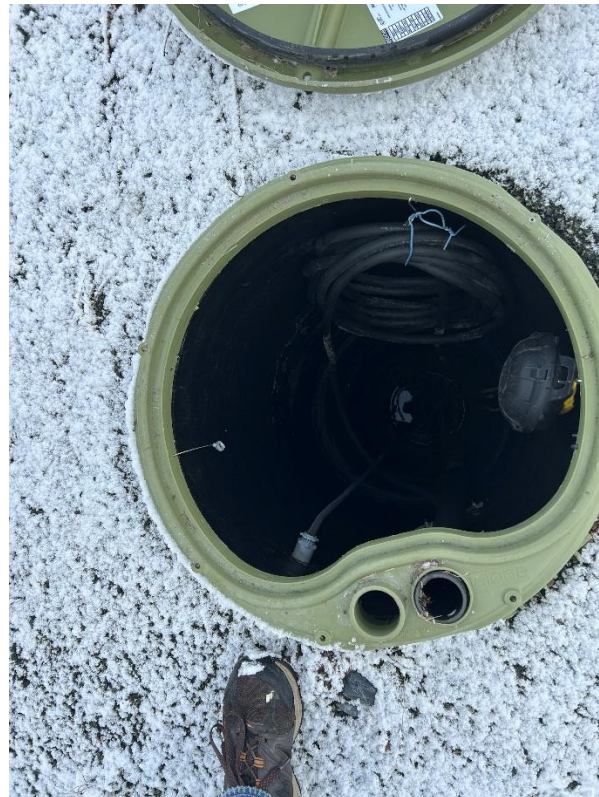
likely beyond the end of their useful life. Before they are replaced with new pumps, the system should be verified as to proper insulation to ensure that it does not freeze during the winter.

Figure 9. Lift station near water facility building, with no evidence of insulation

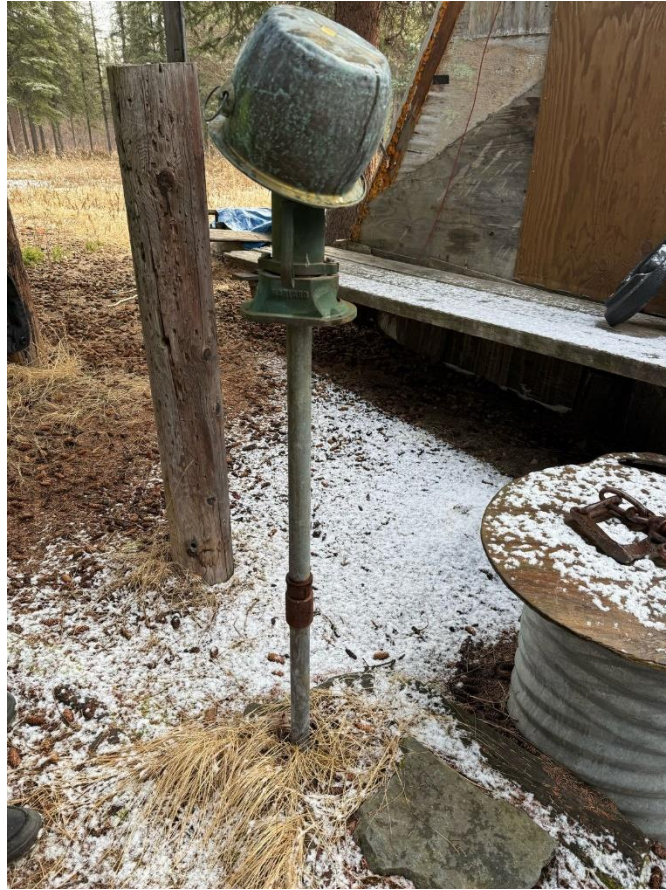
The owner of Home #2 stated that although he has a drinking water well, it is not operational as he needs help with installation of piping. Currently, he's either buying or hauling water for his home, and using an outhouse. The property is large enough for construction of a leach field and the well would probably need to be relocated, for separation distance requirements. The home likely lacks adequate space for a bathroom.

Figure 12. Groundwater Well at Home #2

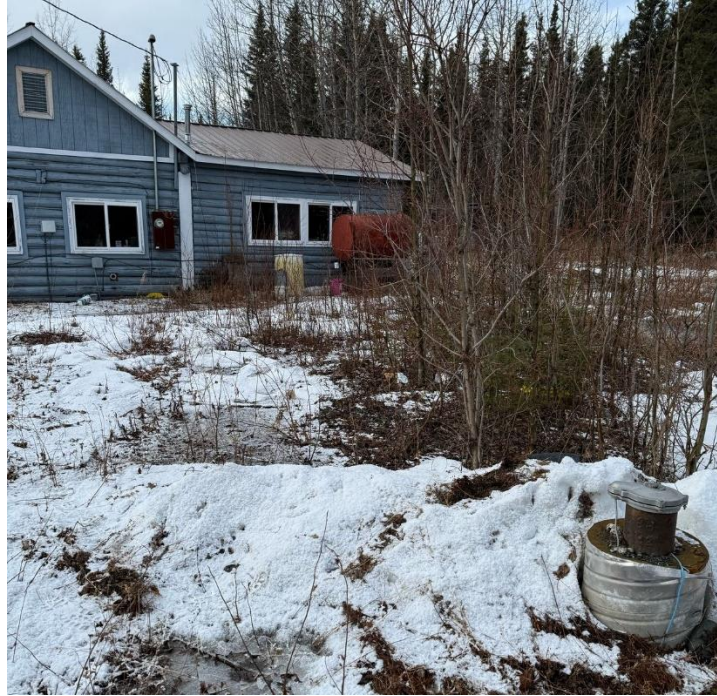
The home has an operational well drilled over 30 years ago. The septic system has failed, and an outhouse is currently being used. The home has structural concerns and may need significant repairs. It has previously been occupied year-round and may be again.

Figure 13. Groundwater well used in Home #3

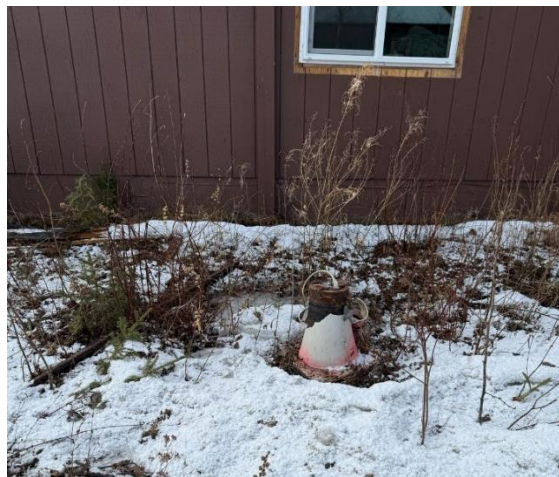
The house has a working groundwater well and a septic system, the well is very close to the residence, and meeting separation distance requirements needs to be evaluated.

Figure 14. Home #4 working groundwater well

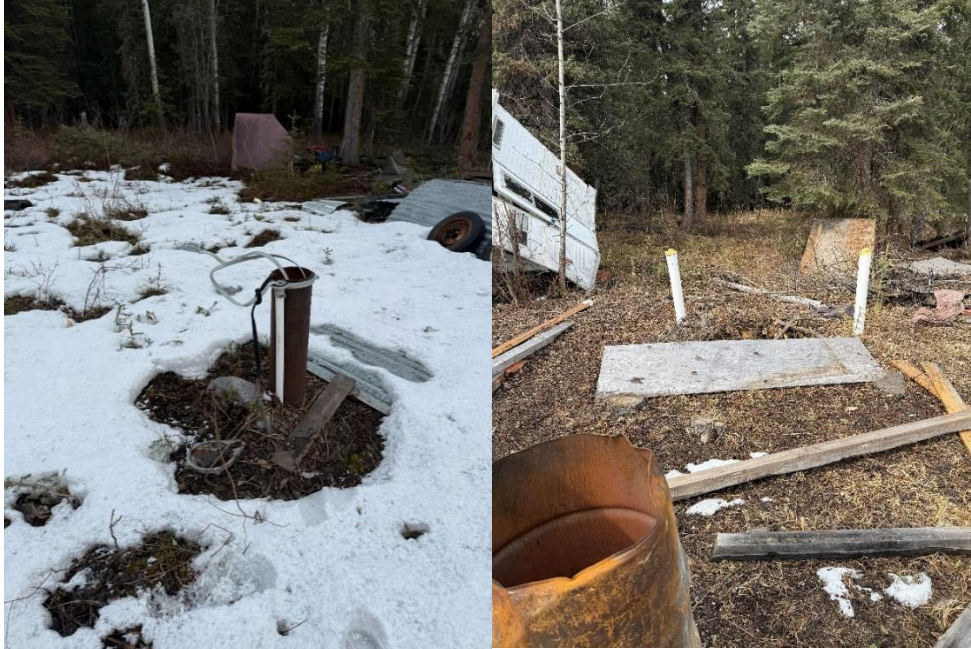
Home #8 has a working well, close to the house, and a septic system. The building is being remodeled currently and has enough room for a kitchen and bathroom.

Figure 15. Groundwater well and septic system

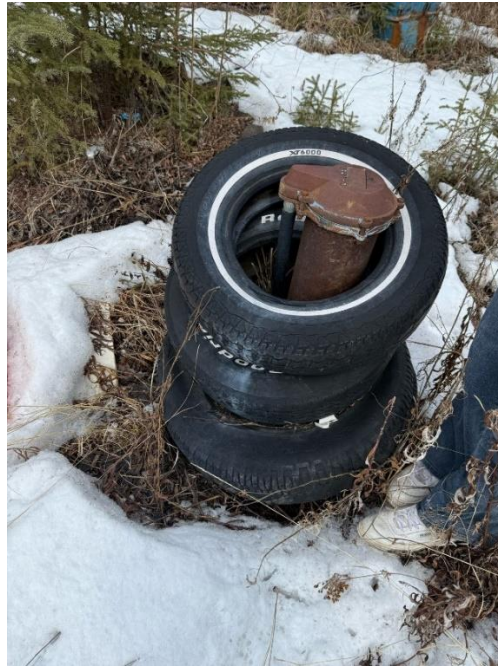
For home #9, a septic system and groundwater well were identified in the property but were never hooked up to the house. The current condition of the systems is unclear, as the house is not occupied at the moment.

Figure 16. Home #9 working well

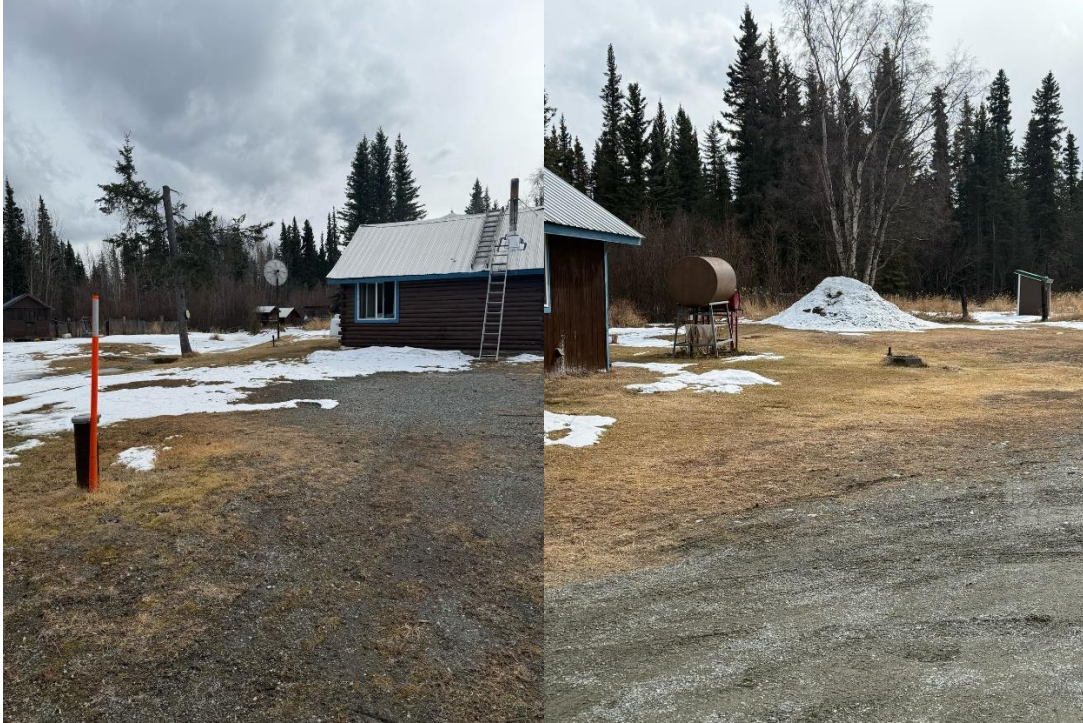
Home #12 has a working well, with potentially high iron content, based on visual observation. The septic system, although operational, is past its useful life, as it was built in the 1980's.

Figure 17. Home #12 groundwater well and septic system
